## Product Update – Suppressor Material Change 6/15/2020

### RegO LV4403 Series Vent Screen Inspection/Replacement

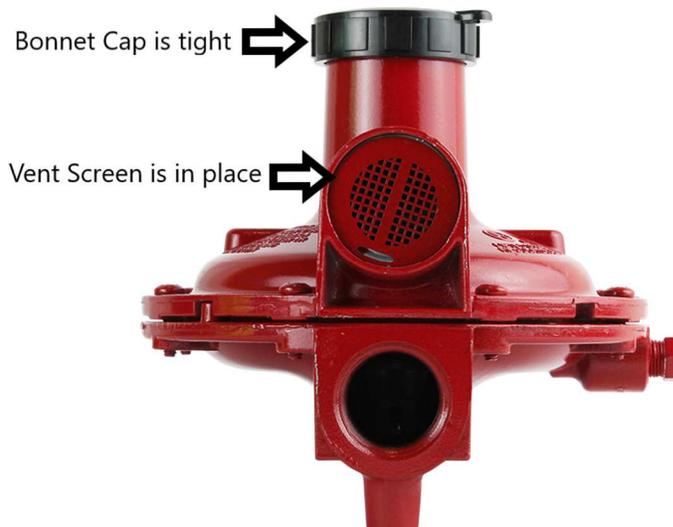
1. Check bonnet cap to confirm it is tight and the vent screen/suppressor is in place and is secure. If the vent screen/suppressor is missing replace it.

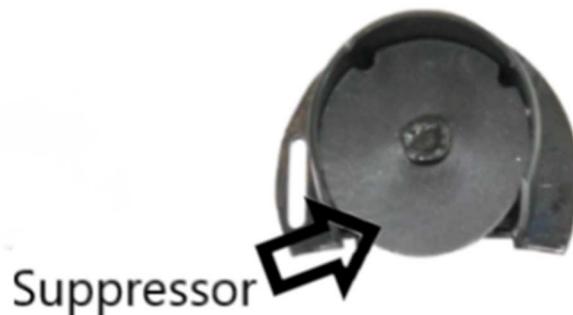
3. Inspect the vent screen/suppressor for damage, the suppressor should be in place and flat against the ID of the vent screen as shown below. The vent screen should be uniform with no signs of gashes or damage to the screen.

We have become aware of reports concerning the suppressor which is part of the vent screen installed on LV4403TR series first stage regulators specifically coming from the Midwest region of the USA. We have found that the suppressor is curling away from the internal diameter of the vent opening; when this occurs a vibration and noise (hum) can occur when gas is flowing through the regulator.

Based on outside analysis it has been determined that the material currently used for the suppressor can be affected by atmospheric exposure over many years which affects the ability of the material to remain flat.
