REVISED FIELD ADVISORY
Supersedes RegO Field Advisory Issued on February 3, 2017

L7579 1-3/4" X 1-1/4" MNPT Filler Valve
Date Codes 8B16 to 1C17

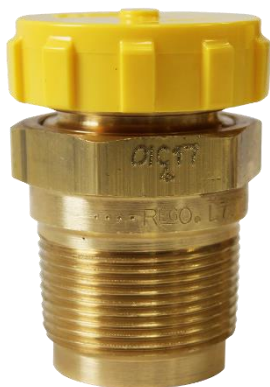
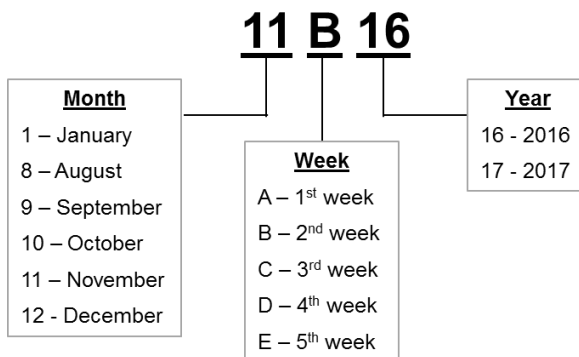
Date Code Identification

The dates of manufacture of the valves covered by this field advisory are August second week 2016 (8B16) to January third week 2017 (1C17).

1. We advise that you use a 3179 Filler Valve Adapter whenever you fill through an affected L7579 fill valve with date codes of 8B16 to 1C17, which is consistent with best industry practices for safety during every fill operation. If for some reason you did not use a 3179B fill adapter and have an issue disconnecting from any fill operation, please exercise extreme caution and follow your company procedures to prevent an accident.
